Project Experience Oil and Gas

Project information

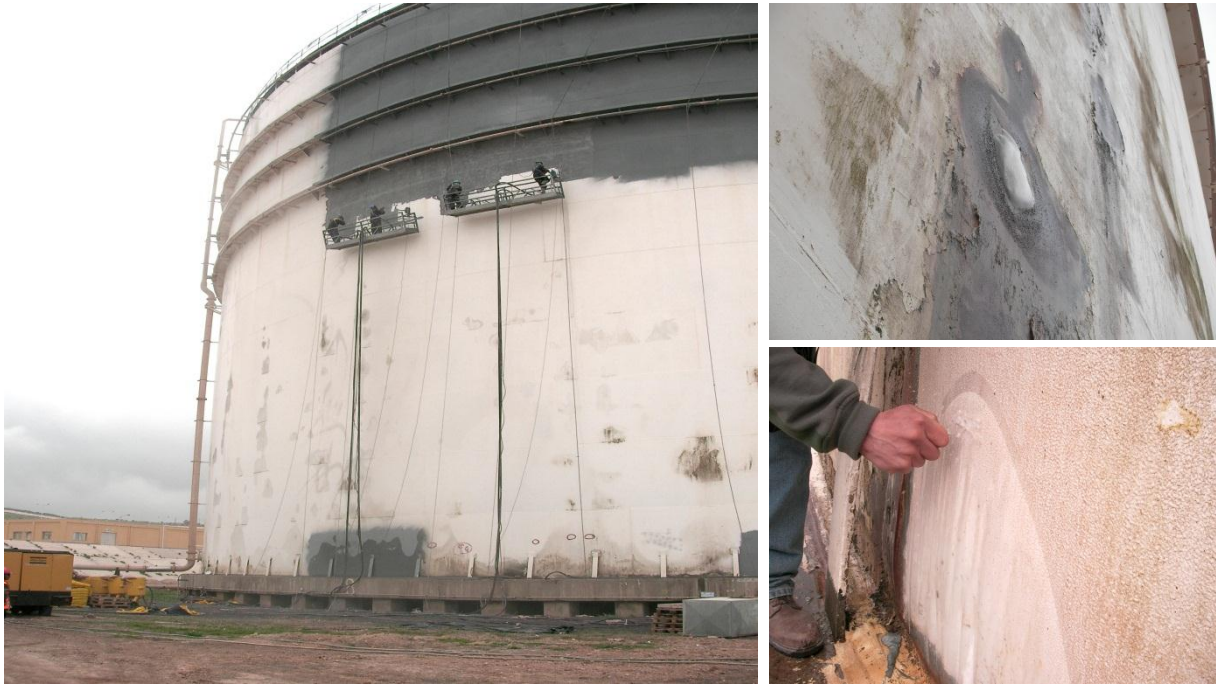
Six 73.000 m³ LNG gas storage tanks (operating at minus 42° C constant) had severally failing coating protection. These double skin tanks had also failing insulation that caused severe ice formation and algae forming on the outer surface.

The original recoat spec was a 3 layer system with a well know 2 pack epoxy/PU system, but the conditions were too extreme to use 2 pack coatings an MCU-Coatings was called to solve the problem. The specifications were changed to MCU-Coatings and with success a 2 layer system was applied in situ.

This project shows the tremendous advantages of MCU-Coatings' 1 component systems including primers and finish coats under these harsh conditions. Tolerance to immediate formation of condense after abrasive blast and ice forming on top of the fresh applied paint. Succes from this type of application is only seen with MCU-Coatings.
